## Winter Growth Water Damage Restoration Showcase

**Flood Damage Pro (Green Cleaning Systems Inc.) - IICRC Certified Firm**

This is the case study of the water damage restoration project performed by Flood Damage Pro at Winter Growth in Olney, Maryland, near Montgomery General Hospital.

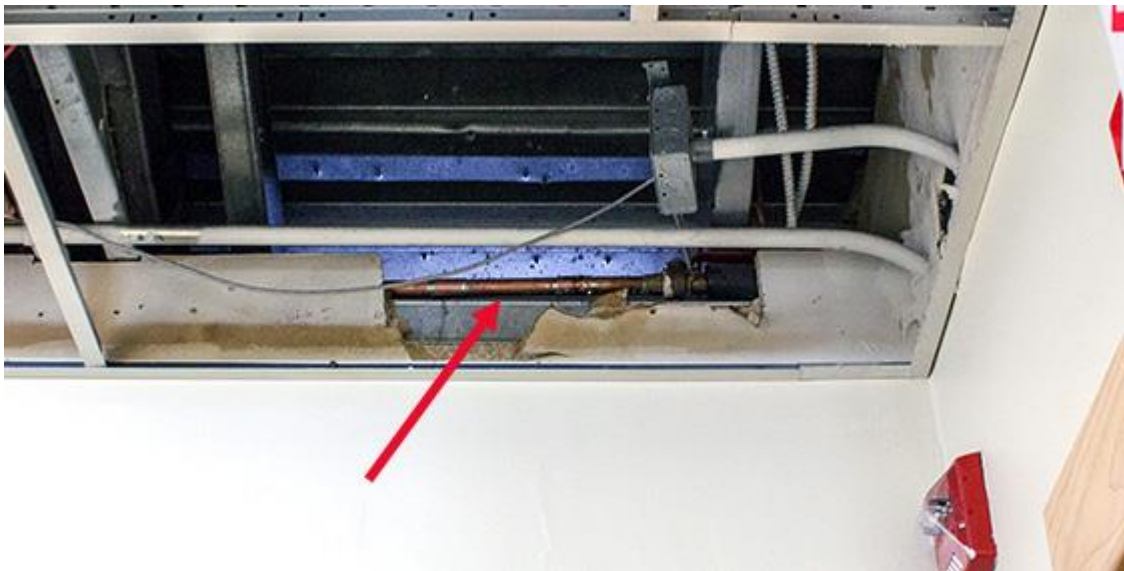
On February 21, 2015, a pipe burst in the ceiling at Winter Growth's Montgomery Center in Olney, Maryland.

The leak originated in the ceiling above the Lion's Den exit door, a large room containing many valuable furnishings such as billiard table, a grand piano, and the center's fitness and group activities furniture.

The remains of the flood destroyed the surrounding ceiling panels and soaked through carpeting across the Lion's Den and adjacent areas, including the main entrance of the facility, the office of the Admin Assistant/Volunteer Coordinator, the main hallway, the Social Services office, the Activity Workroom, and the adjoining wall to the Green Room, as well as in all storage closets in those areas. The water was drawn from the carpeting into the carpet covered baseboards, causing damage to the bottom edge of the drywall in all affected areas, in many cases on both sides of the wall.

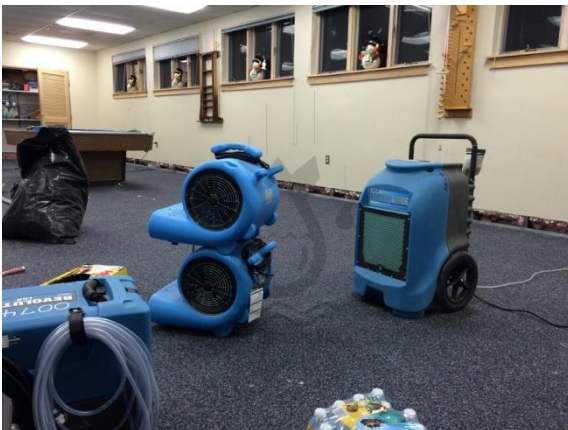
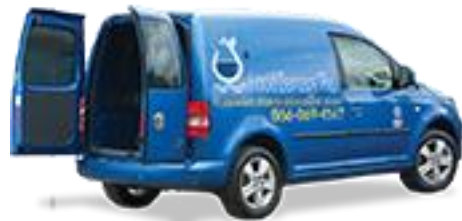
<b>Date Begun:</b>	February 22, 2015
<b>Date Completed:</b>	March 6, 2015
<b>Total Duration of project:</b>	13 days
<b>Dehumidifiers:</b>	Revolution LGR ( 1 Unit) Capacity: <ul style="list-style-type: none"> <li>▪ 80 pts./day   38 L/day at 80°F/60% RH (AHAM)</li> <li>▪ 139 pts./day   66 L/day at 90°F/90% RH</li> </ul>
	DrizAir 1200 (2 Units) Capacity : <ul style="list-style-type: none"> <li>▪ 64 pts./day   30 L/day at 80°F/60% RH (AHAM)</li> <li>▪ 145 pts./day   68.6 liters /day at saturation</li> </ul>
<b>Air Movers:</b>	<ul style="list-style-type: none"> <li>▪ Dri-Eaz Velo: 885 CFM</li> <li>▪ Dri-Eaz Sahara E: 926 CFM</li> <li>▪ Aqua Dri 3004AD: 2400 CFM</li> </ul>
<b>Air Scrubber:</b>	Nikro PS600 - MINI POLY AIR SCRUBBER <ul style="list-style-type: none"> <li>▪ 99.97% HEPA Filter</li> <li>▪ 3-Stage Filtration</li> <li>▪ 50 - 600 CFM (Free Air)</li> </ul>
